FORMATION OF THE HAGHARTSIN LANDSLIDE (ARMENIA) AS A CONSEQUENCE OF THE VIOLATION OF THE EQUILIBRIUM STATE OF THE SLOPE DURING ENGINEERING

Summary: *The Haghartsin landslide is located on the right bank of the Aghstev River, near the village of Haghartsin. It is an activated part of a large structural ancient landslide formed during a strong earthquake in the Pliocene-Upper Quaternary time. The first landslide phenomena began to be observed in this area in the 80s of the XX century, literally as soon as the pruning of the slope for the construction of roads and railways began. Significant movements first occurred in 1985 on the slope between the railway track and the highway, as well as on the slope above the railway track. In the 90s of the XX century, this section of the railway was completely destroyed, and already in 1996 a landslide body blocked the highway. Currently, landslide movements cover all new areas. The tongue of a landslide almost every year in May blocks the riverbed of the Aghstev River with the corresponding flooding of rural houses.*

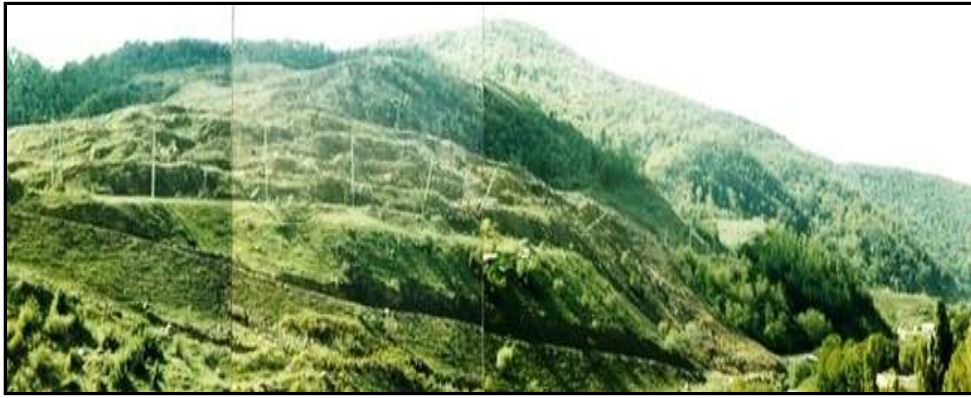
Results and discussion. The Haghartsin landslide is located within the Dilijan basin, on the right bank of the Aghstev river, opposite the village of Haghartsin. The upper absolute mark of the landslide site is 1100m, the basis of erosion is at an altitude of 995m. It is an activated part of a large structural (tectonic-seismogravitational) ancient landslide (see Fig. 1).

Fig. 1. General view of the Haghartsin landslide site.

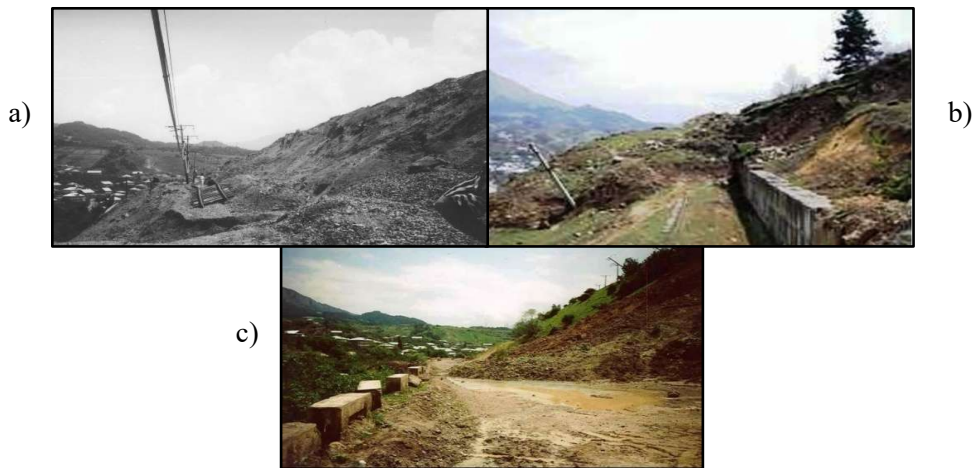
The first landslide phenomena began to be observed at this site in the eighties of the XX century, when the slope was cut for the construction of roads and railways without assessing its stability and the necessary engineering protection. Significant progress first occurred in 1985 on the slope between the railway track and the highway. At the same time, landslide processes began on the slope above the railway track, which contributed to the complete destruction of this section of the railway in the 90s, and already in 1996 a landslide body blocked the highway (see Fig. 2).

Fig. 2. The railway destroyed by a landslide - a); blocked by climb down masses the railway track - b); the bypass road - c).

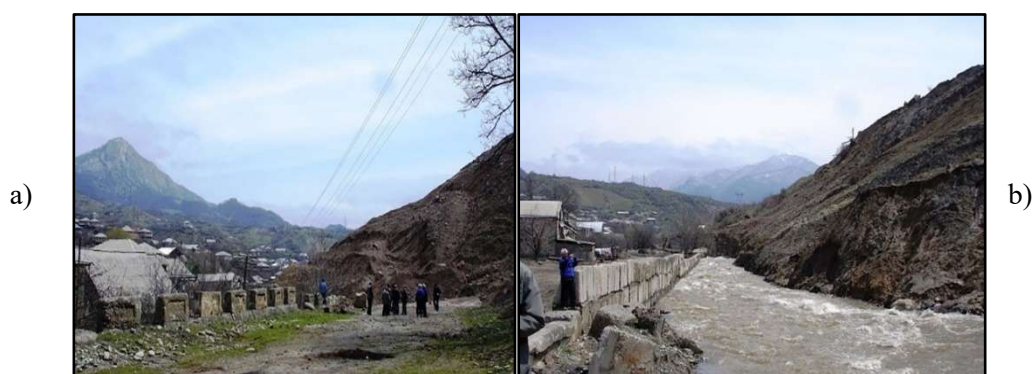
The Haghartsin landslide developed on a slope composed of a volcanogenic-sedimentary complex of rocks of the Middle Eocene, covering mid-quaternary landslides and modern (proluvial, alluvial-proluvial, eluvial-deluvial and lacustrine) formations [7]. The Eastern block (block 1) is characterized by the greatest activity, in the body of which a number of local landslide stabs are distinguished. The active state of block 1 provoked the movement of neighboring blocks and the formation of a single landslide array with one breakaway point, as well as a change in vectors and displacement velocity. The landslide block 1 has a length of 190m, a width of 200m, an area of 37,000 m², the volume of the displaced mass is 1,026,000 m³. The sliding plane passes at a depth of 15 to 23 m in deluvial-proluvial formations, sometimes captures hydrothermally altered bedrock. The structure of block 1 involves loose-block slope formations (deluvium, defluction), technogenic accumulations, deluvial-proluvial formations (lenses of bentonite clays, clay-loamy soils with layers of gravel and gravel), alluvial and alluvial-proluvial accumulations of terraces of the river Aghstev, as well as Middle Eocene andesites and andesite-dacites and their modified differences. In the period from 2000 to 2010, the entire landslide site was activated as a result of the termination of engineering protection works (the creation of a buttress and drainage system, unloading measures, partial unloading of the tongue part of the landslide zone along the railway track, as well as the construction of wall drainage and upland ditches to intercept atmospheric and man-made waters) due to lack of funding [6]. The consequence of this was a catastrophic displacement of the earth masses and the actual unification of all three landslide blocks into a single whole. The railway track was completely destroyed, the bypass road was put out of operation. In April 2001 the tongue of the landslide dammed 75% of the riverbed of the Aghstev river, which required large expenses for its cleaning from the debris of the soil (see Fig. 4).

Fig. 4. A bypass road blocked by a landslide - a); landslide masses that collapsed into the riverbed of the Aghstev river - b).

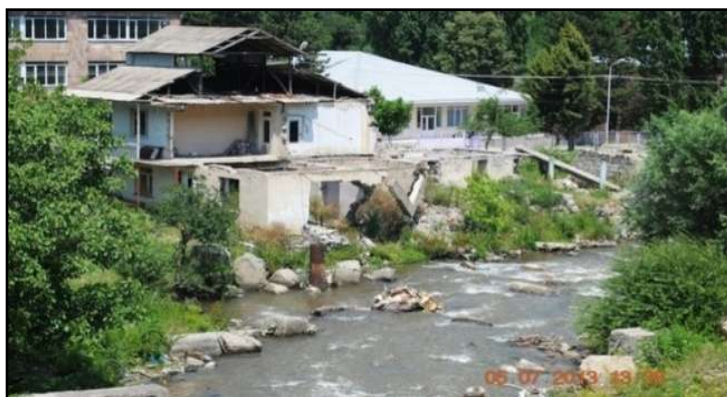
New landslide movements with riverbed closure occurred on May 27, 2005 and April 28, 2006. At the same time, the lower floors of more than 20 houses with their homesteads, a rural school (in its northern building, the height of the water level was 1.2 m) were flooded. After 2006, almost every year in the spring, landslide masses block the riverbed, creating a lot of problems not only for the villagers, but also for the

Ministry of Emergency Situations of the republic. The houses of the residents of the village of Haghartsin are destroyed as a result of constant flooding (see Fig. 5).

Fig. 5. Destroyed buildings on the left bank of the Aghstev river (05.07.2013).

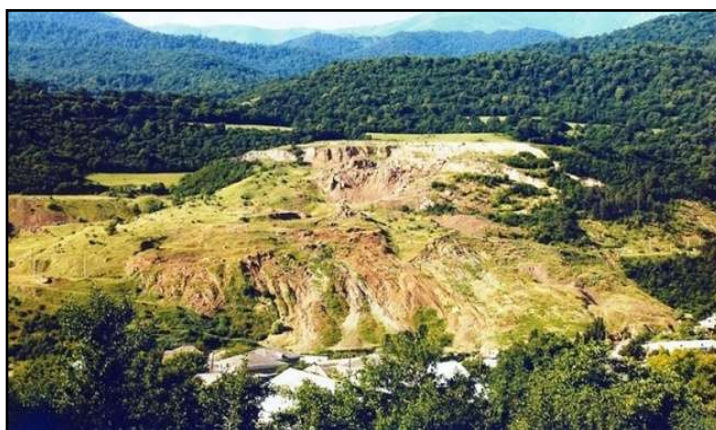
Conclusion. To date, the situation at the landslide site “Haghartsin” is extremely critical. Landslide movements cover all new areas not only in breadth, but also up the slope and down the depth (see Fig. 6).

To stop a landslide, comprehensive protective measures are needed: drainage of watered rocks; piercing with piles buried in the underlying rocks below the sliding mirror; artificial improvement of the properties of sliding soils (cementation, the use of Uisit powder - developed by employees of the former Dilijan expedition of the IGS NAS RA together with geologists of Moscow State University, etc.). However, all this requires large financial investments, which the republic is currently unable to implement.
